UNDERWATER BRIDGE INSPECTION REPORT

STRUCTURE NO. 73534

SAUK RIVER

DISTRICT 3 – STEARNS COUNTY

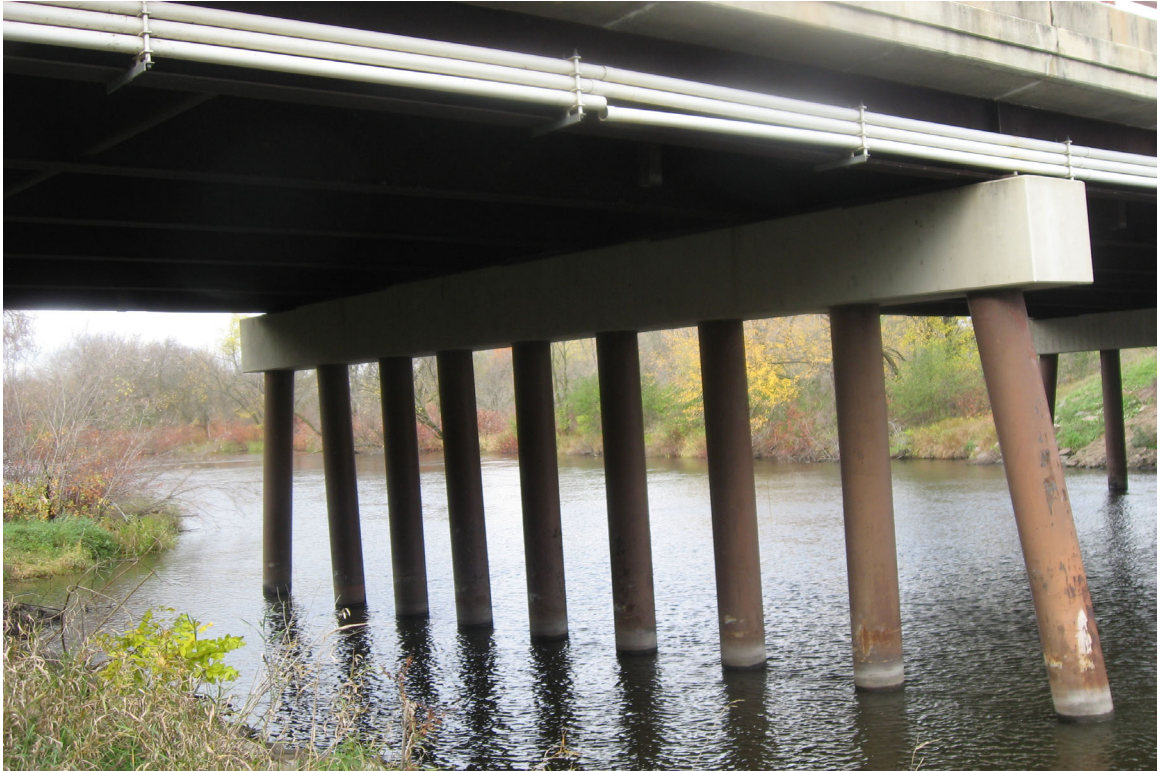
Photograph 1. View of Pier 1, Looking North.

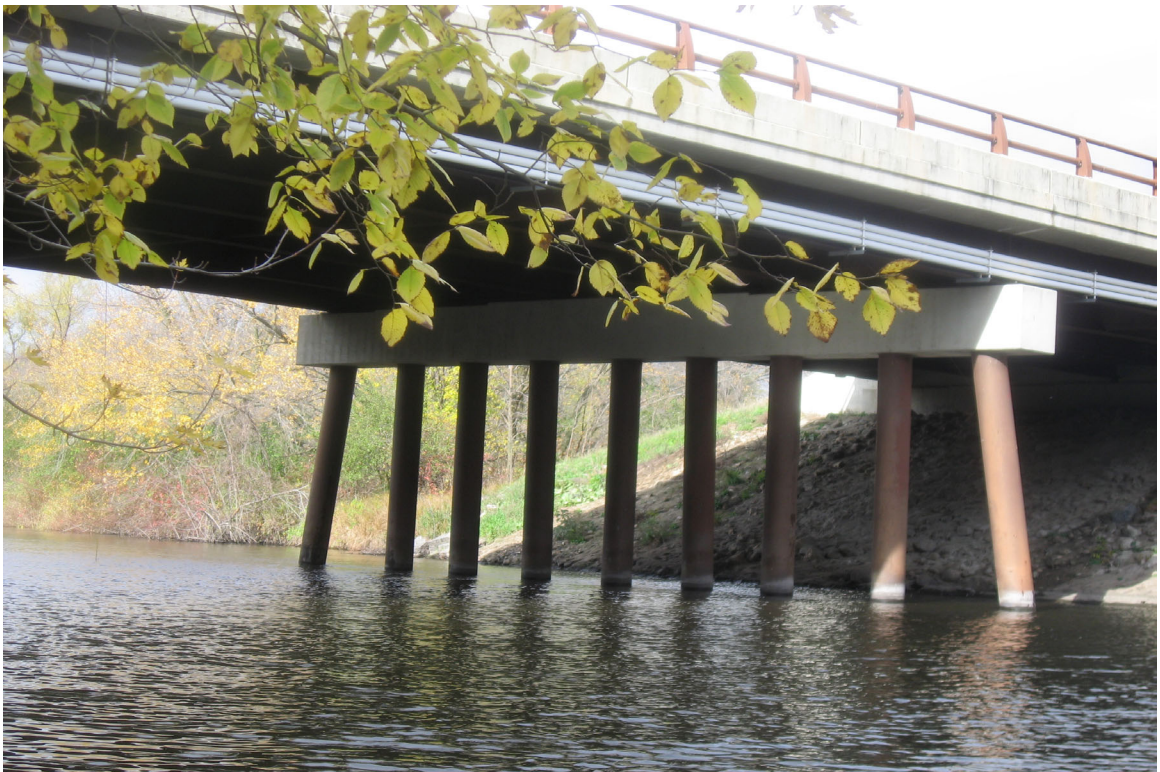
- (A) The steel piles exhibited coating failure and fairly uniform light surface corrosion from 1 foot above the waterline to the channel bottom with random rust nodules up to 1/2 inch in diameter and associated pitting 1/16 inch deep over 10 percent of the surface area.
- (B) A light accumulation of timber debris consisting of 3 inch diameter and smaller branches was observed scattered along the entire perimeter of Pier 2.

Photograph 2. View of Pier 2, Looking Northwest.

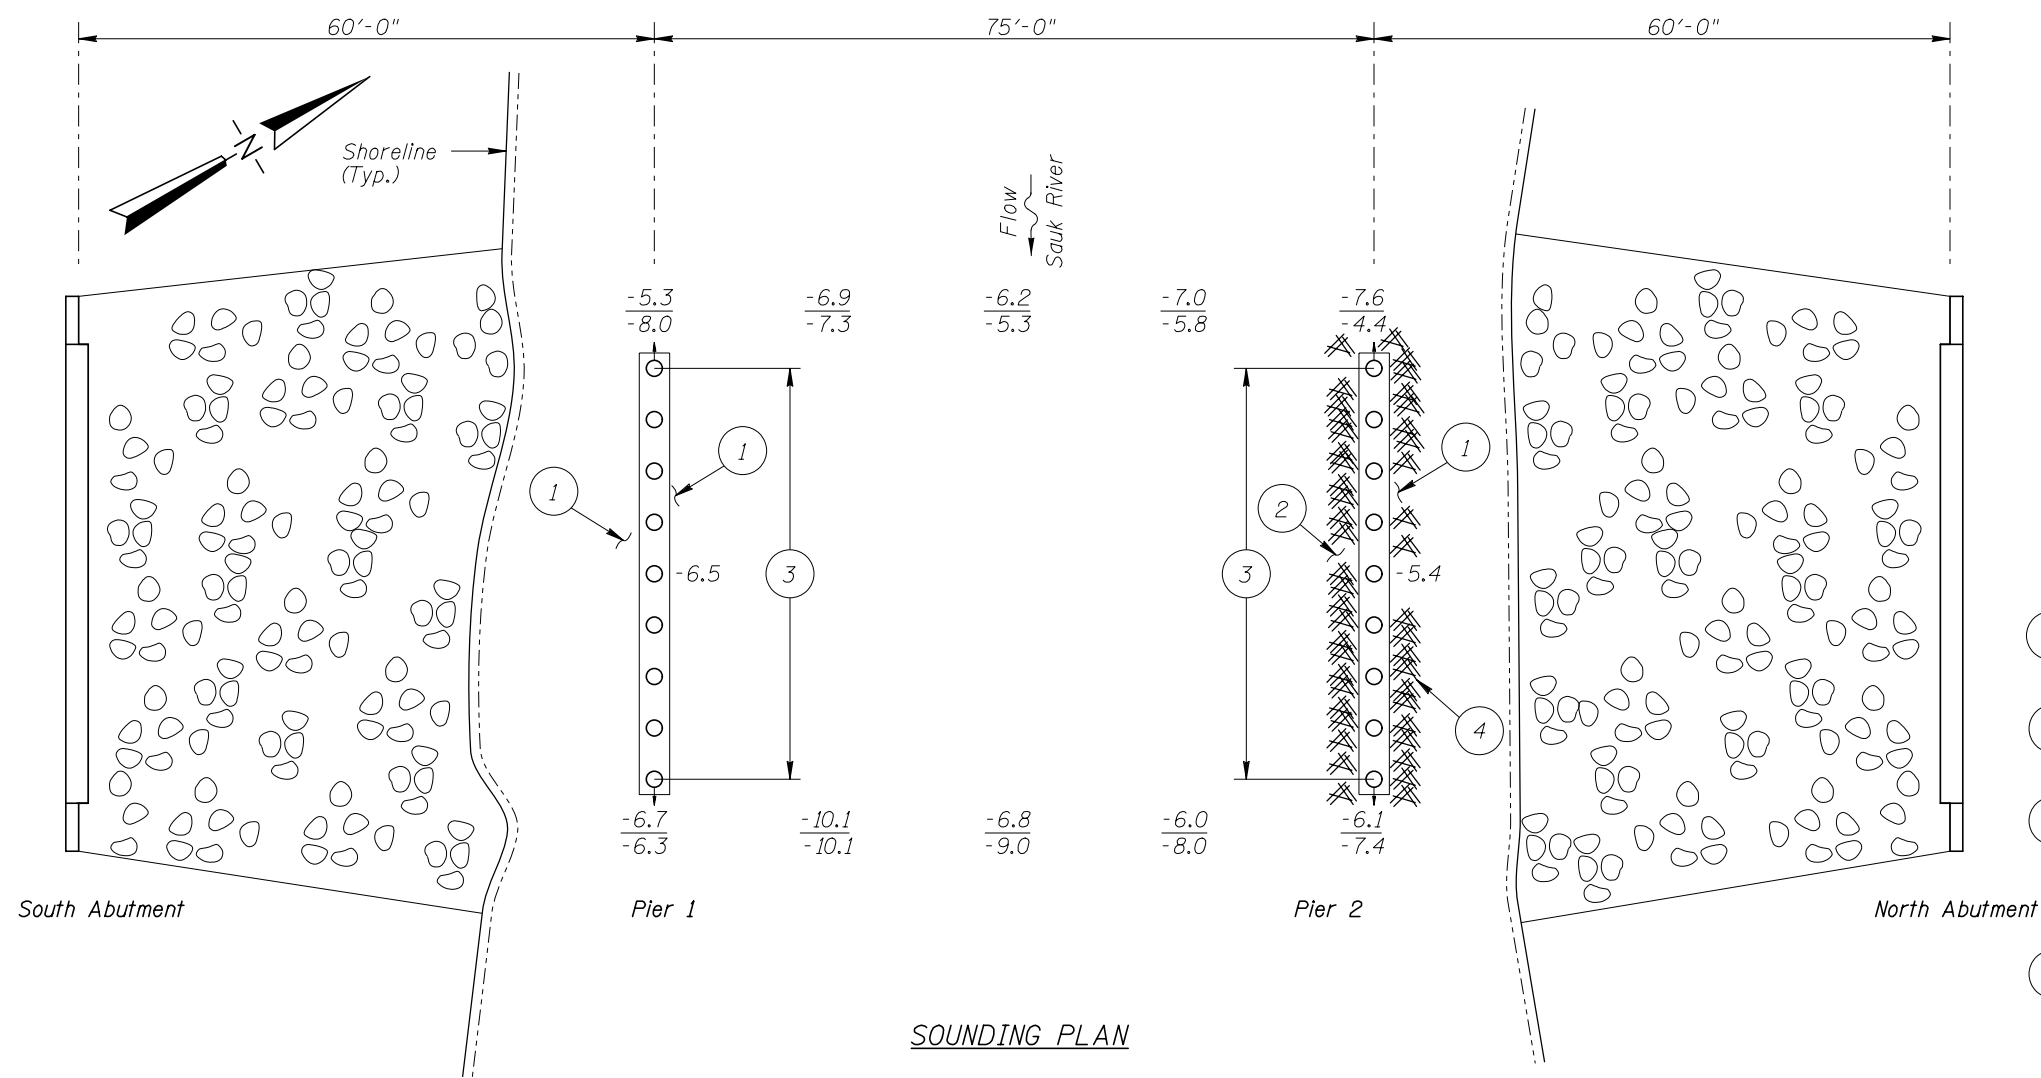
TYPICAL END VIEW OF PIER S

- The channel bottom consisted of sand and silt with 1 to 2 foot diameter riprap and 3 inches of probe rod penetration.
- The channel bottom consisted of sand and gravel with up to 4 inches of probe rod penetration.
- The steel piles exhibited coating failure and fairly uniform surface corrosion from 1 foot above the waterline to the channel bottom with random rust nodules up to 1/2 inch in diameter with pitting 1/16 inch deep, over 10 percent of the surface area.
- Light accumulation of timber debris consisting of 3 inches in diameter and smaller branches was observed scattered along entire perimeter of Pier 2.
